**Visual Simulation 7:  
Western Corridor from Ruby  
Road west of the Tumacacori  
Mountains.**

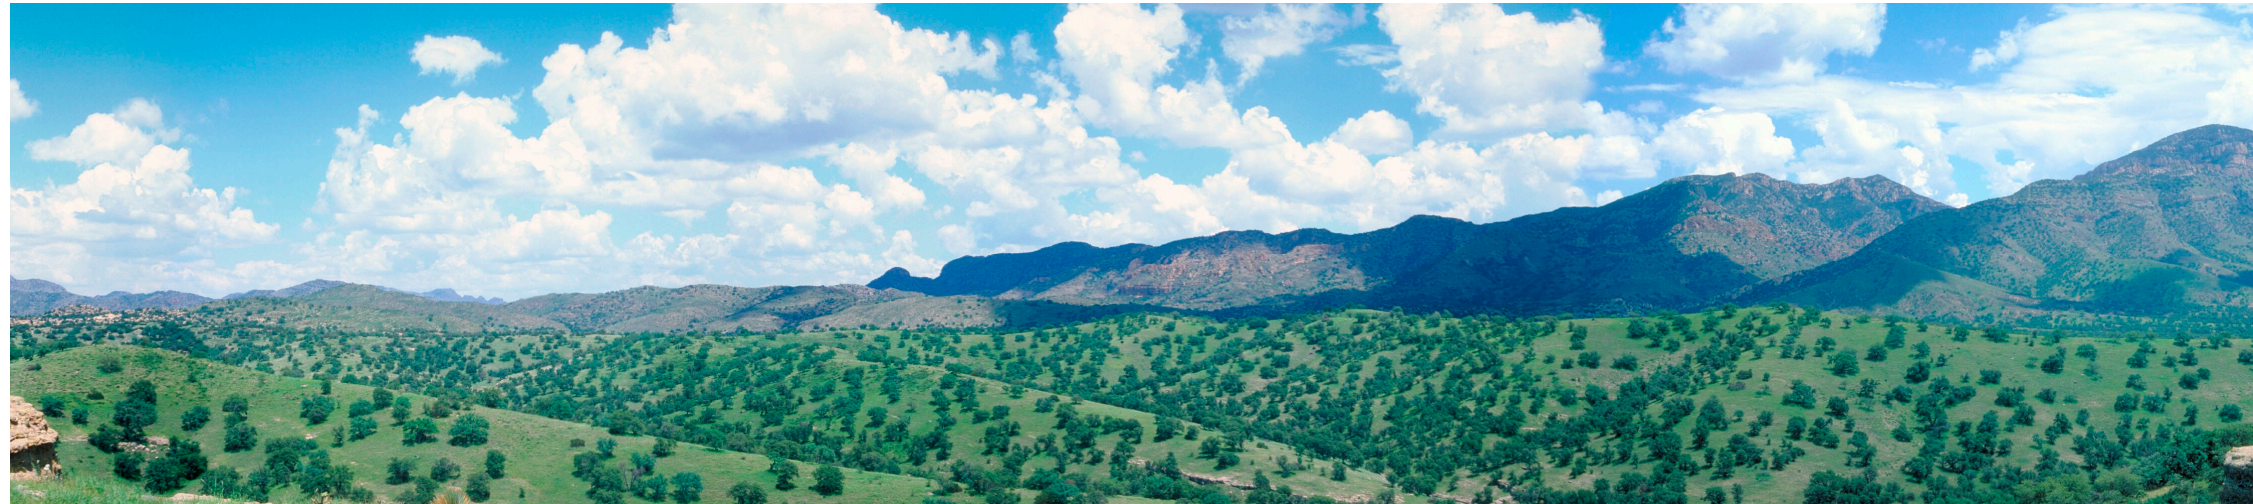
Existing Conditions: View from Ruby Road looking northeast along the west side of the Tumacacori Mountains.

An example, wide-open view of the Western Corridor from a Concern Level 1 travelway.

**Direction:** Northeast  
**Distance to Nearest Pole:** 0.8 mi

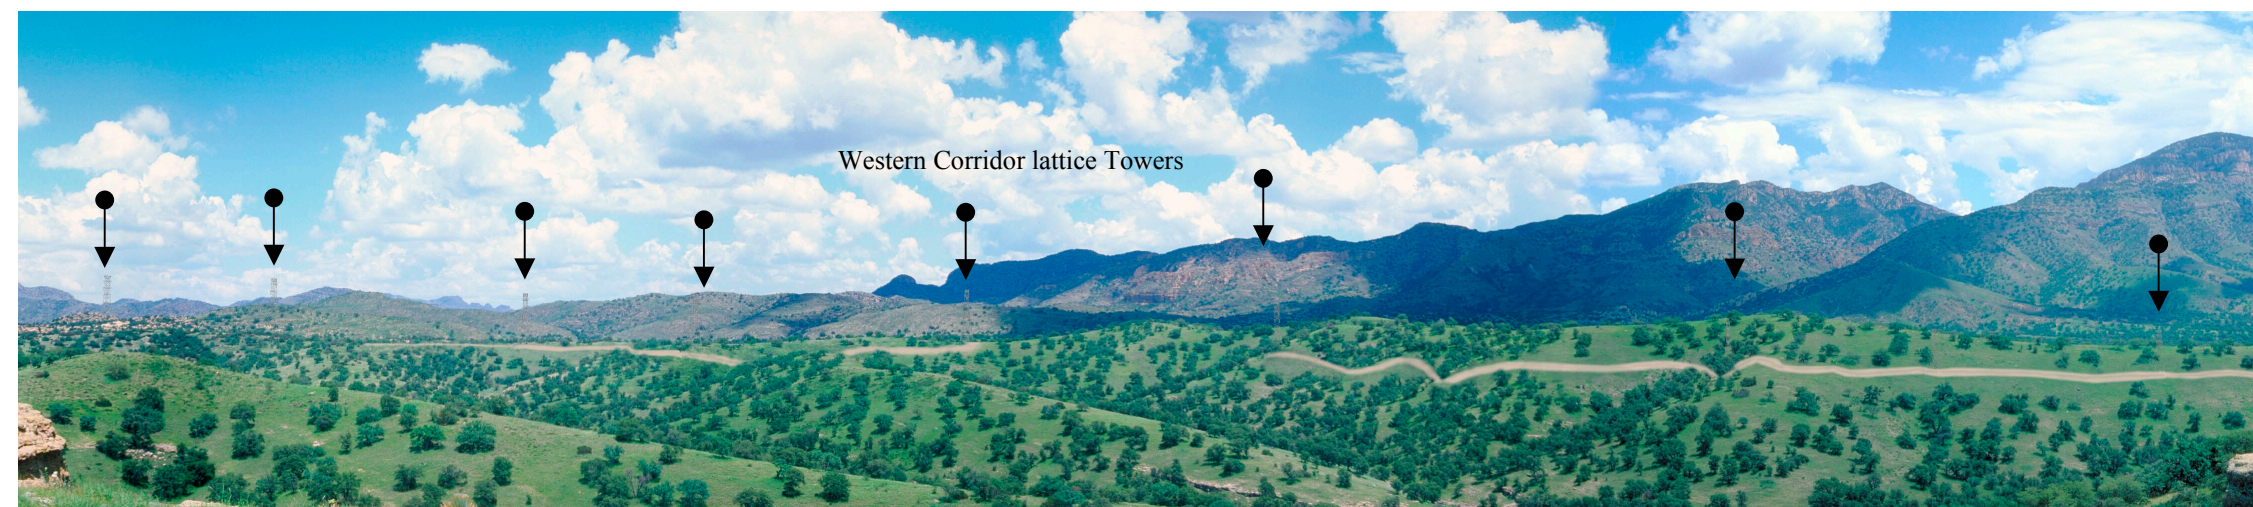
Visual Simulation: Depicting dulled galvanized lattice towers with access roads required for this type of structure.
